**MISCELLANEOUS RANDOM DEFECTS – SOME ACTUALLY QUITE SERIOUS**

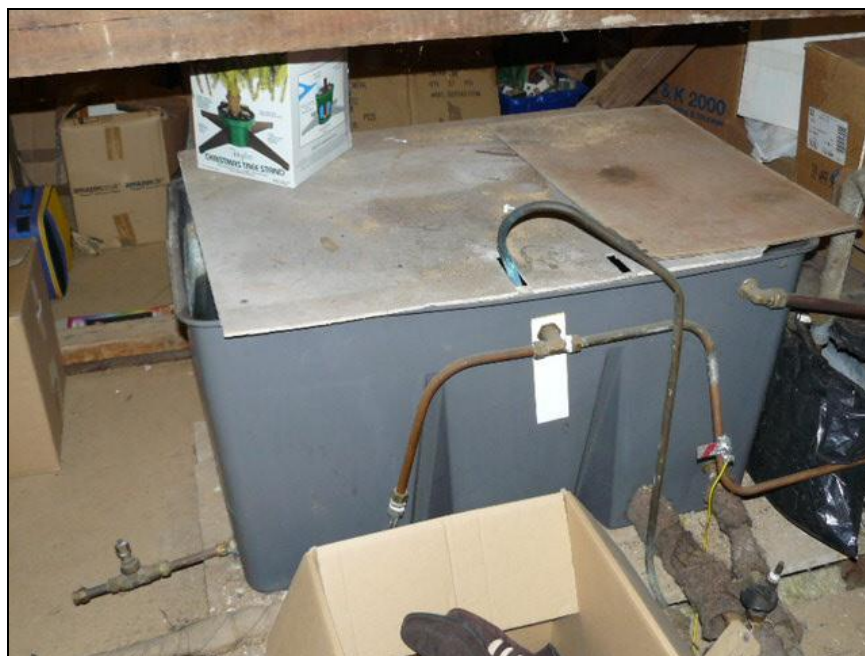
**New pipe water tank but pipework untidy, no lagging and the board looks suspiciously like hard asbestos cement.**
