**MISCELLANEOUS RANDOM DEFECTS – SOME ACTUALLY QUITE SERIOUS**

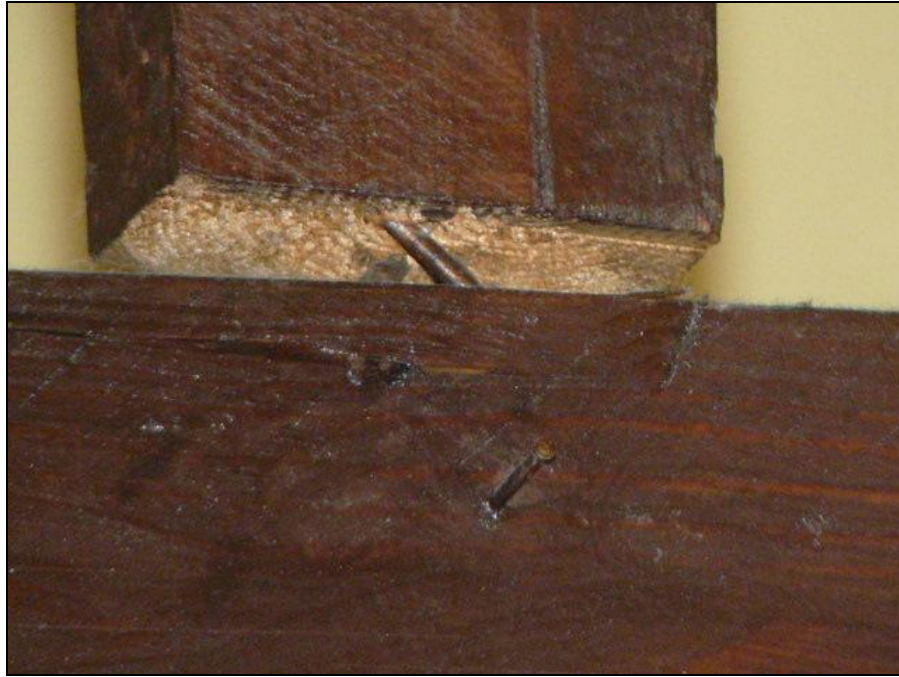
**Dramatic failure of an exposed roof truss. Nail fixings are just not going to work.**

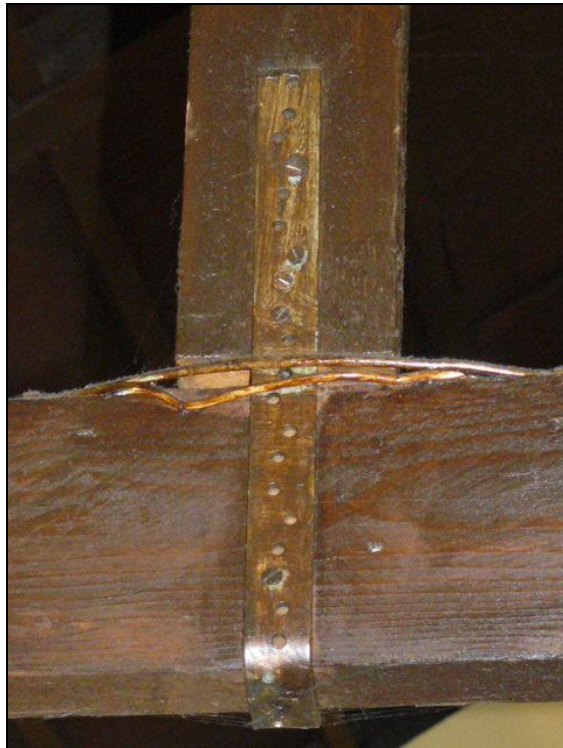
**Never mind we will try some strapping and a lot of screws, that will fix it. I think not!**

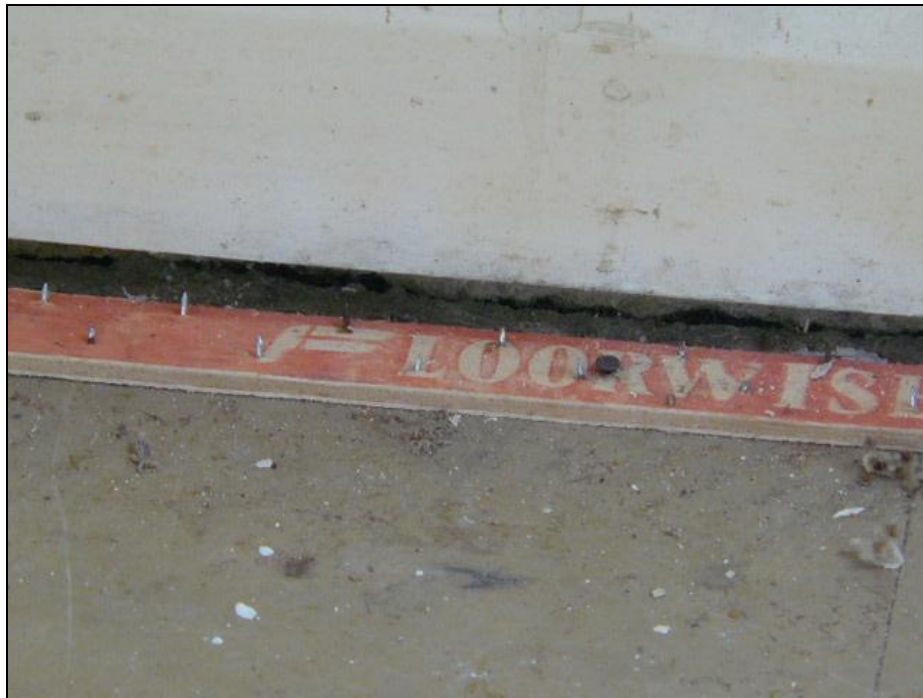
**Not uncommon floor slab movement to 1960's bungalow. This is the resultant gap between the floor and skirting board.**

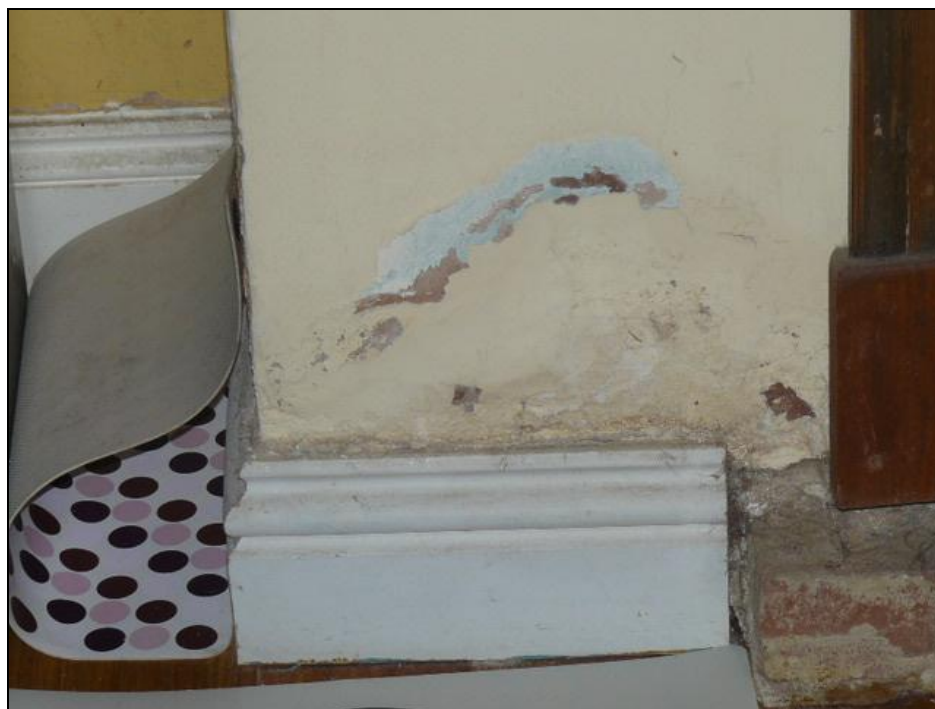
**Damp treatment definitely needed to this kitchen wall.**

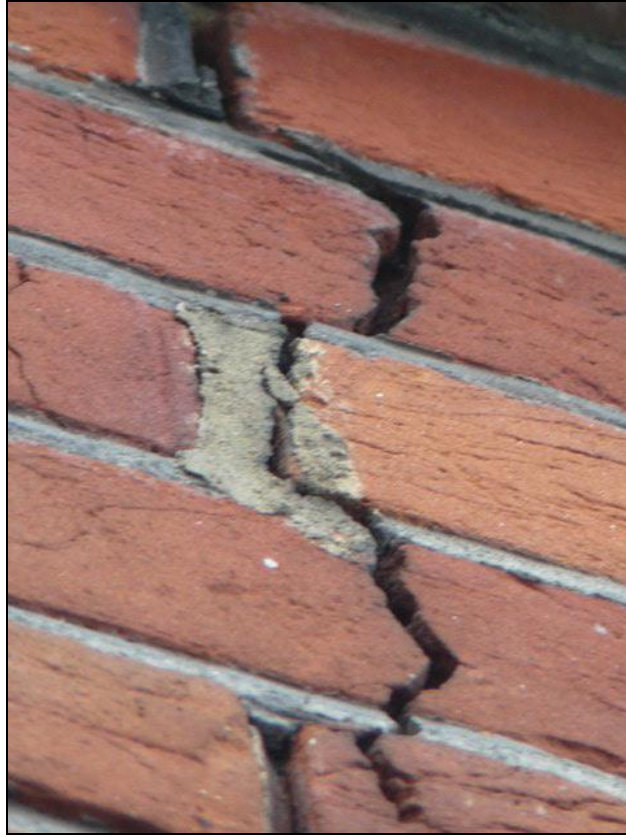
**Significant cracking to external brickwork. The crack does appear old.**

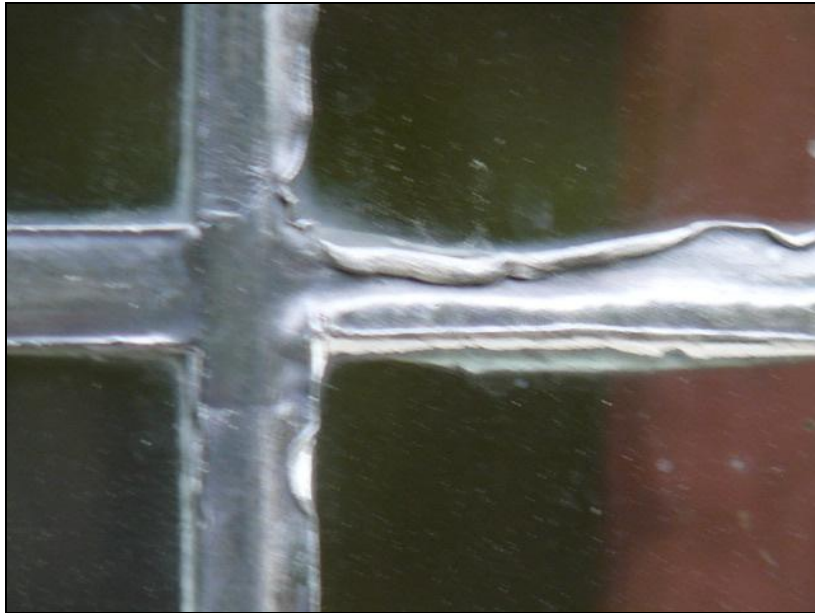
**Lead lights to windows look good but are a maintenance item.**

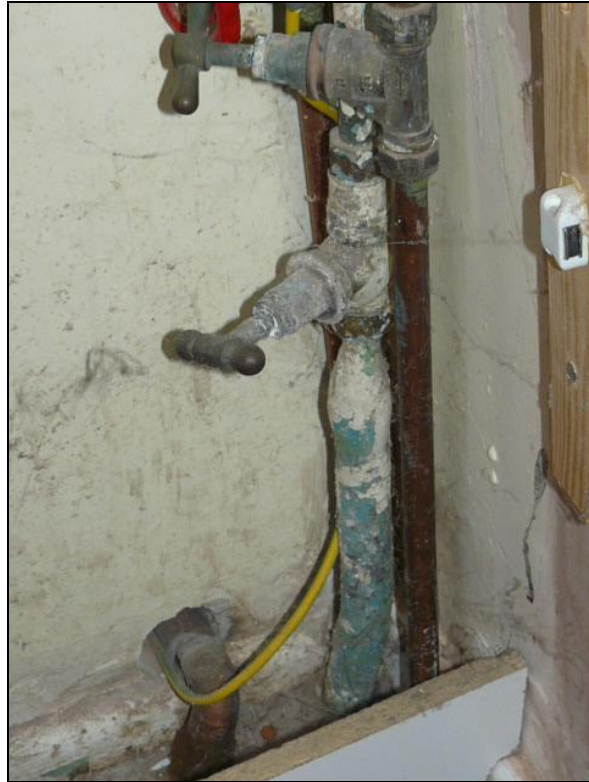
**Lead pipe to incoming water main – not that unusual with older properties.**

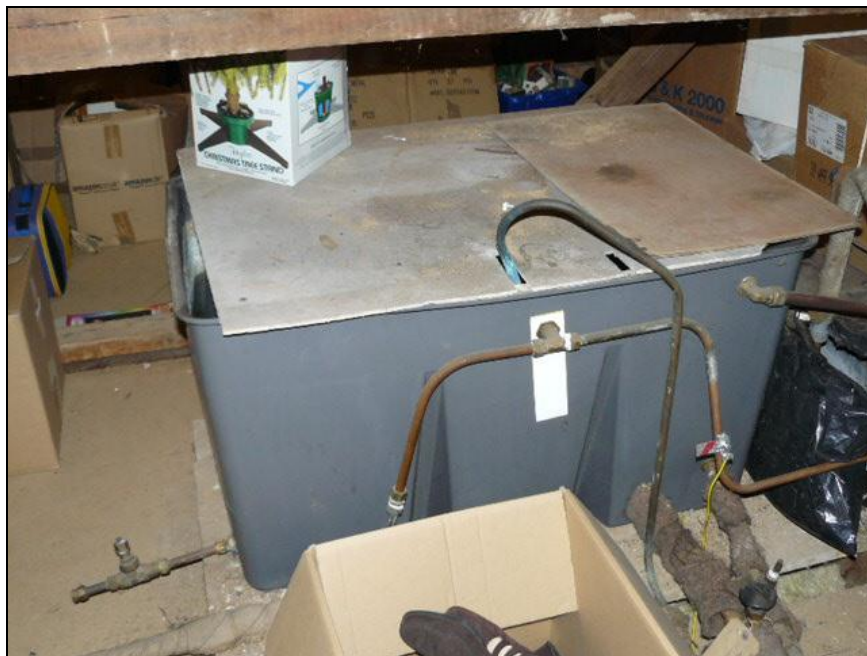
**New pipe water tank but pipework untidy, no lagging and the board looks suspiciously like hard asbestos cement.**

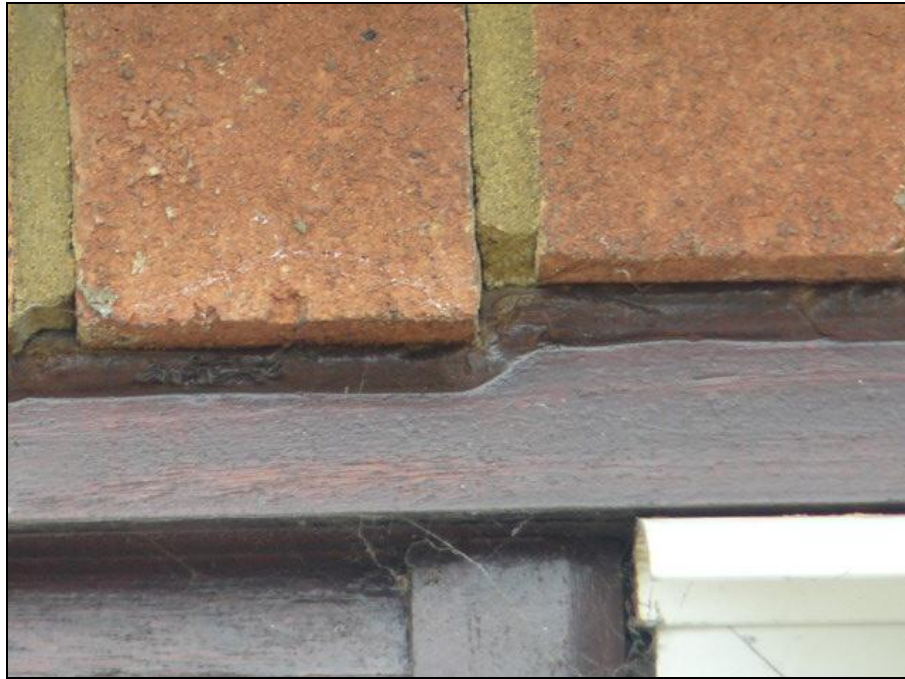
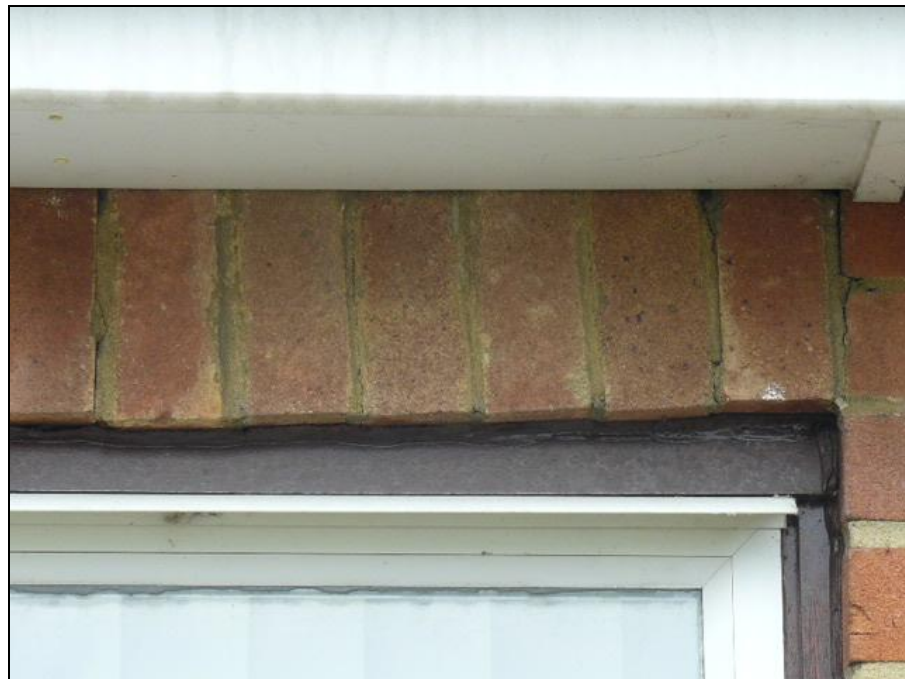
**1950's house often supported the outer skin of cavity brickwork on the original metal casement windows. Here the windows have been replaced but the bricks have slipped down – a lintel should have been provided.**

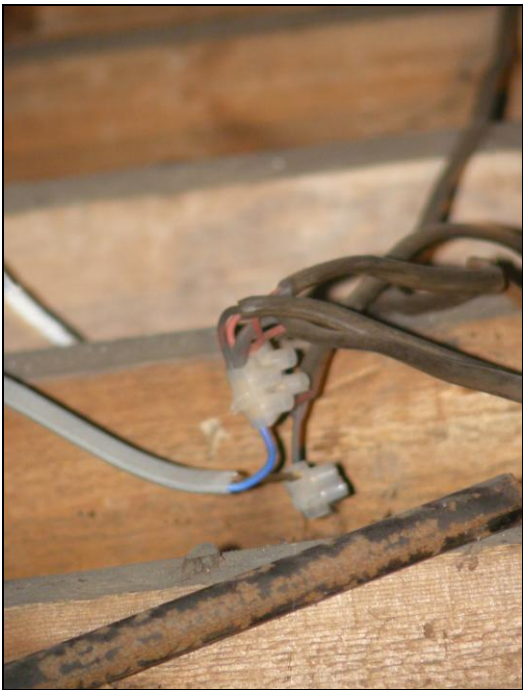
**The electrical wiring at this house leaves a lot to be desired. Here new PVC insulated wires have been joined to old rubber insulated cables.**

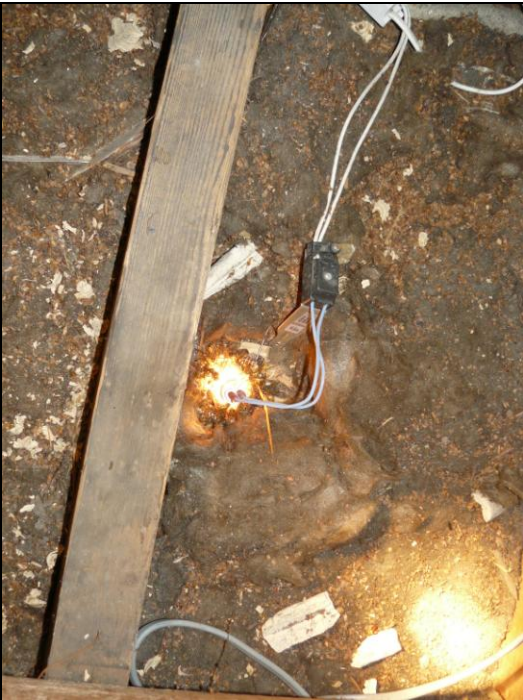
**The warmth and light of these exposed ceiling lights were too much for these suicidal wasps. You could smell them burning! All very hazardous and potentially costly - especially when the agreed purchase price was just under £1 million!**
