MISCELLANEOUS RANDOM DEFECTS – SOME ACTUALLY QUITE SERIOUS

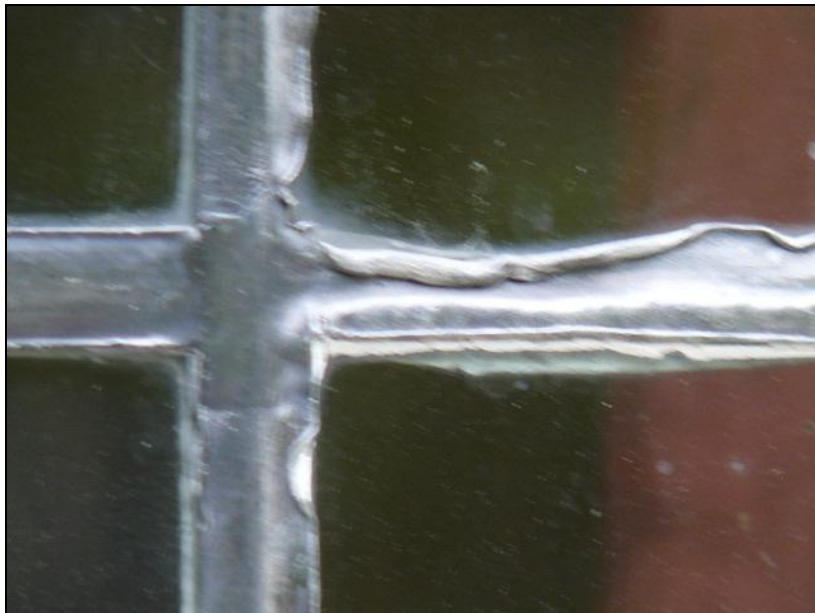
Lead lights to windows look good but are a maintenance item.

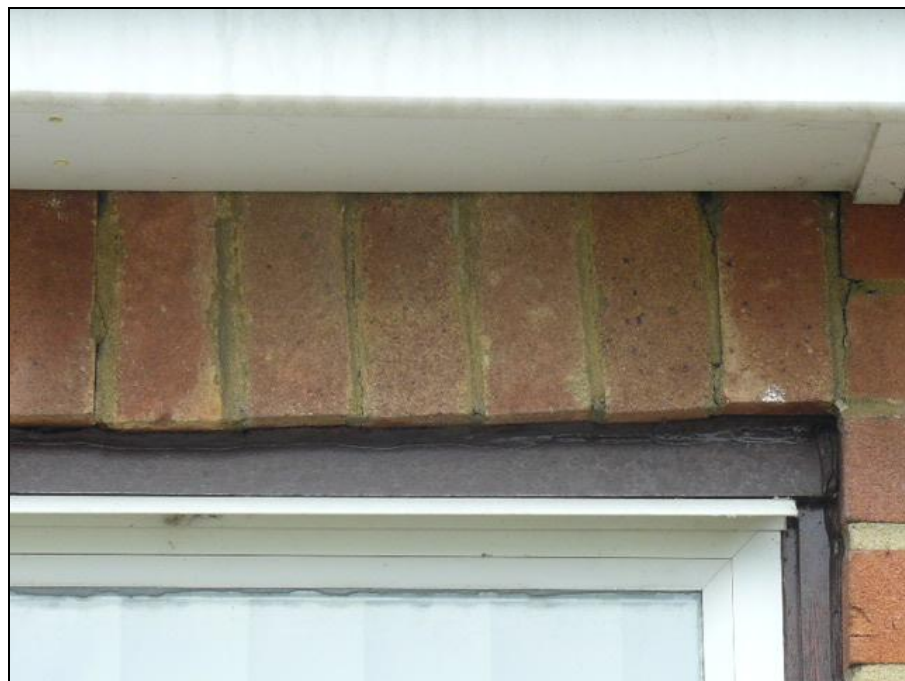
1950's house often supported the outer skin of cavity brickwork on the original metal casement windows. Here the windows have been replaced but the bricks have slipped down – a lintel should have been provided.
